FORCON INTERNATIONAL – VIRGINIA, LTD.

Subject: Blacksburg High School Gymnasium Collapse

Your Claim # DMF 3428; FORCON CASE # V10155

SUBJECT: Blacksburg High School Roof Truss Support – Case V10155
Lehigh Project Number: 2736-10
PO # Case V10155

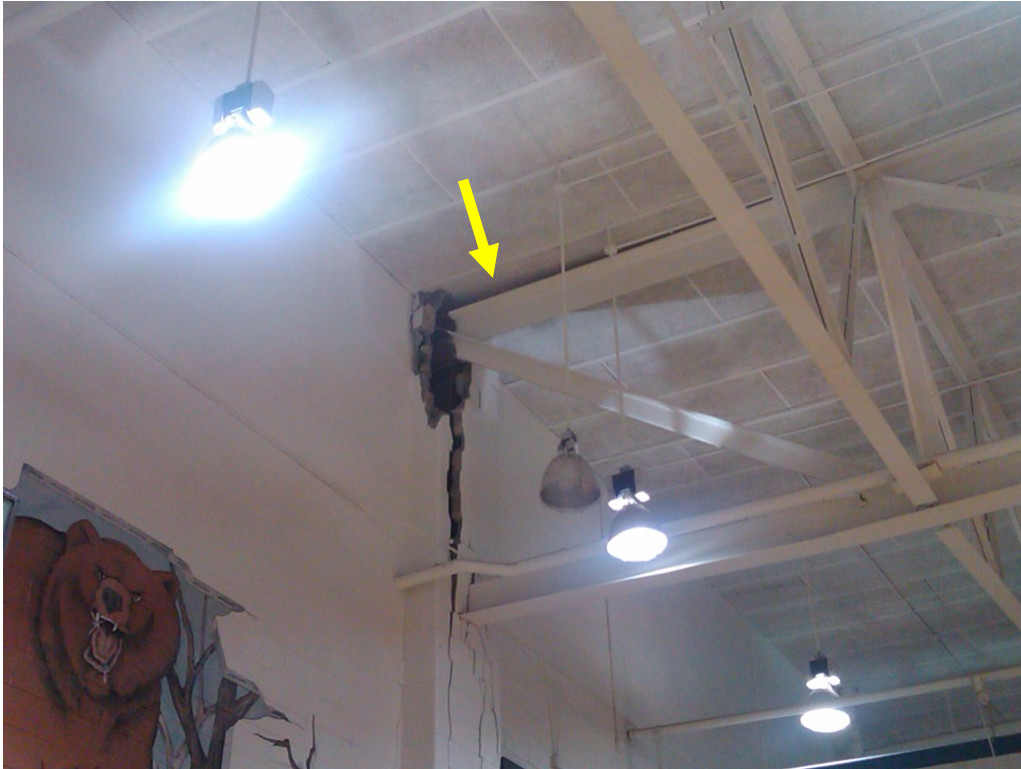
Lehigh Testing Laboratories received both the southwest and northwest ends of a truss including the supports. This system had been used to support the gymnasium roof at Blacksburg High School in Virginia. The truss sections were sent after the roof had collapsed on February 13, 2010. At the time of the collapse, the roof was covered with a large amount of snow. Cracks in the wall under the truss top horizontal member on the southwest end and a masonry block on the floor were noticed during girls' basketball practice. The building was evacuated as a precautionary measure and the roof subsequently collapsed during the same day. A coach took cell phone photographs of the cracked wall prior to evacuation (Figures 1 and 2). The masonry block surrounding the support column had cracked into fissures propagating in the downward direction, and the top member of the truss had already separated from the roof adjacent to the southwest wall. In addition, the top member of the truss had already moved to the left edge of the masonry block column while the bottom member was still in the center of the column.

Figure 1: Cell phone picture taken during roof failure shows separation between the top member of the truss and the roof (arrow) on the southwest side.

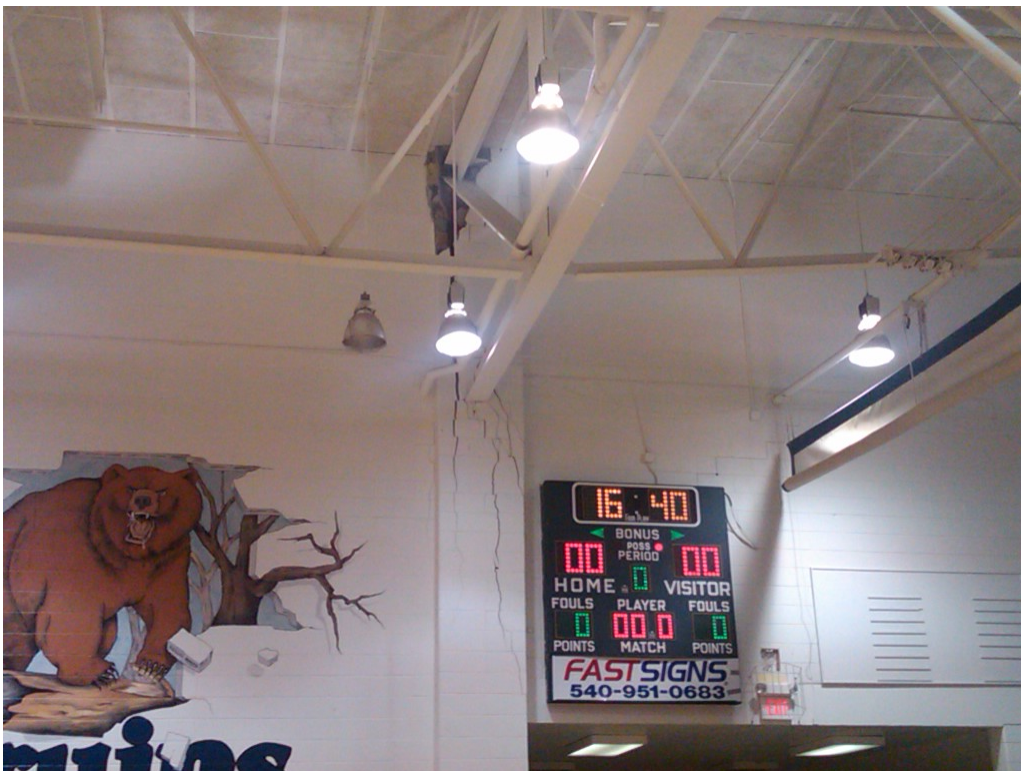
Figure 2: Cell phone picture taken during roof collapse shows southwest side top member pulling to the left side of the column, compared to the bottom member which was located in the center of the column.

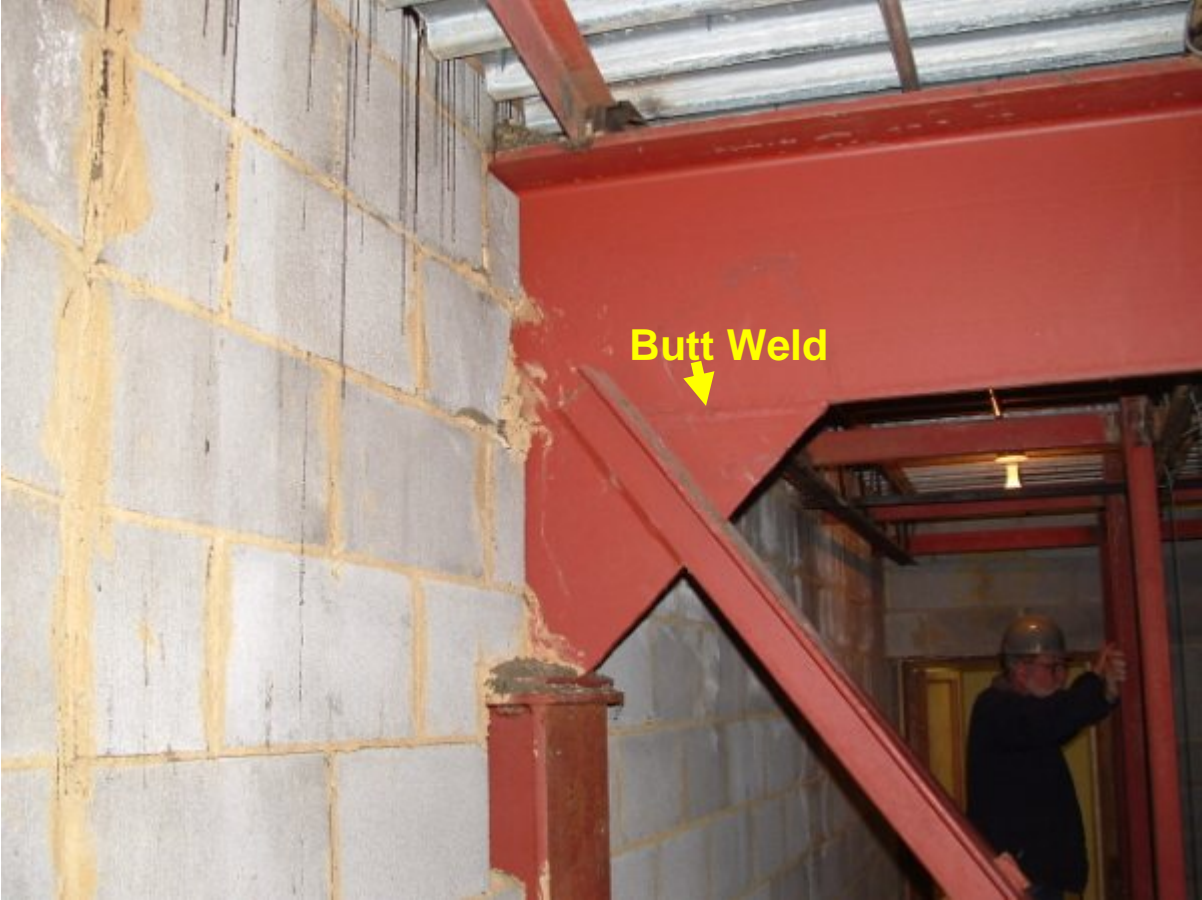
The type of truss construction used is illustrated in Figure 3 which shows a truss and support column in the school auditorium. While this truss is smaller than the gym roof trusses, the general design is the same. Trusses are supported on ends by a steel shape which consists of a vertically-oriented plate (or web) section and a horizontally-oriented base. Four bolt holes are located in the base which allows the truss support to be bolted to a vertical support column. The web passes between two diagonally-oriented members and is, by design, fillet welded to those members. The top of the shape is butt welded to the top horizontal member. The primary difference in truss design between the auditorium and gym roof trusses is that the length of the butt weld to the horizontal member from the gym roof was located below and within the diagonal member while most of the length of the auditorium truss weld was located above the diagonal member. Full penetration is required for this structural weld under ANSI/AWS D1.1. The plate section also was not gusseted. Gussets are perpendicularly-oriented which would have provided lateral support to the plate.

Figure 3: Truss in auditorium illustrates construction geometry. This support uses the same design as the gym roof support but is smaller.

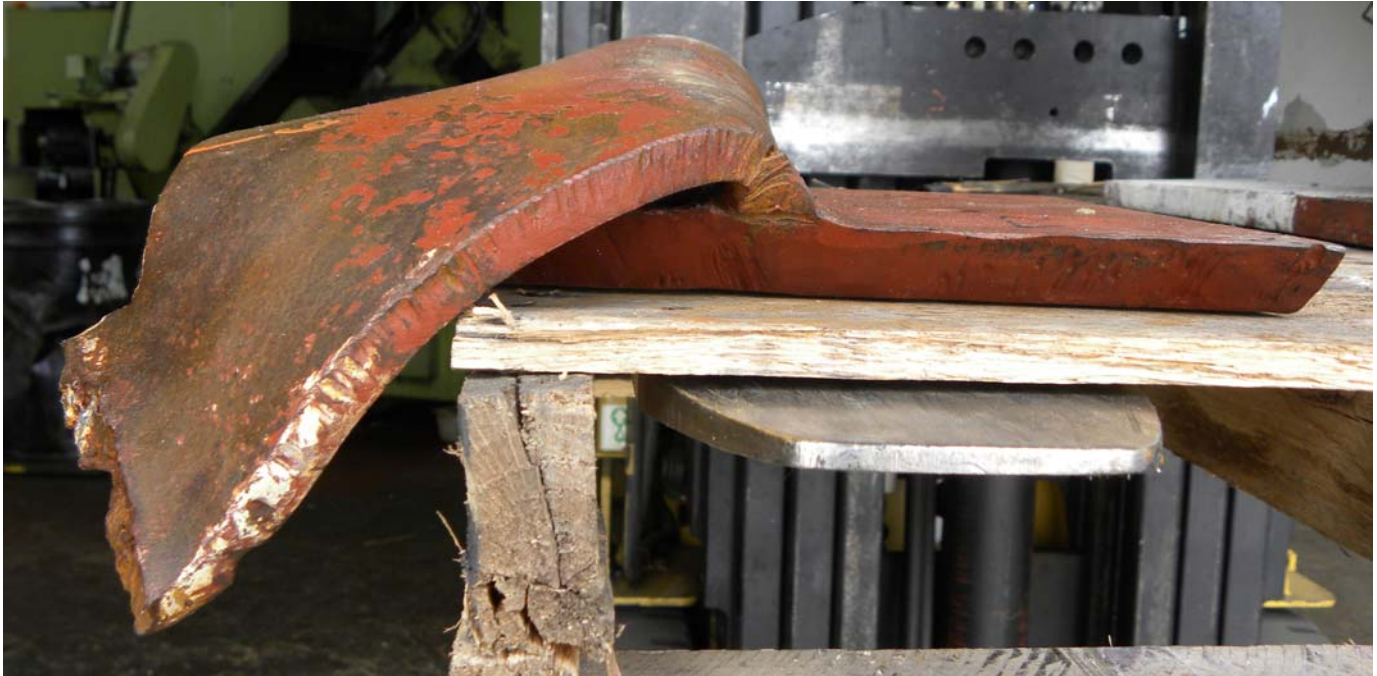
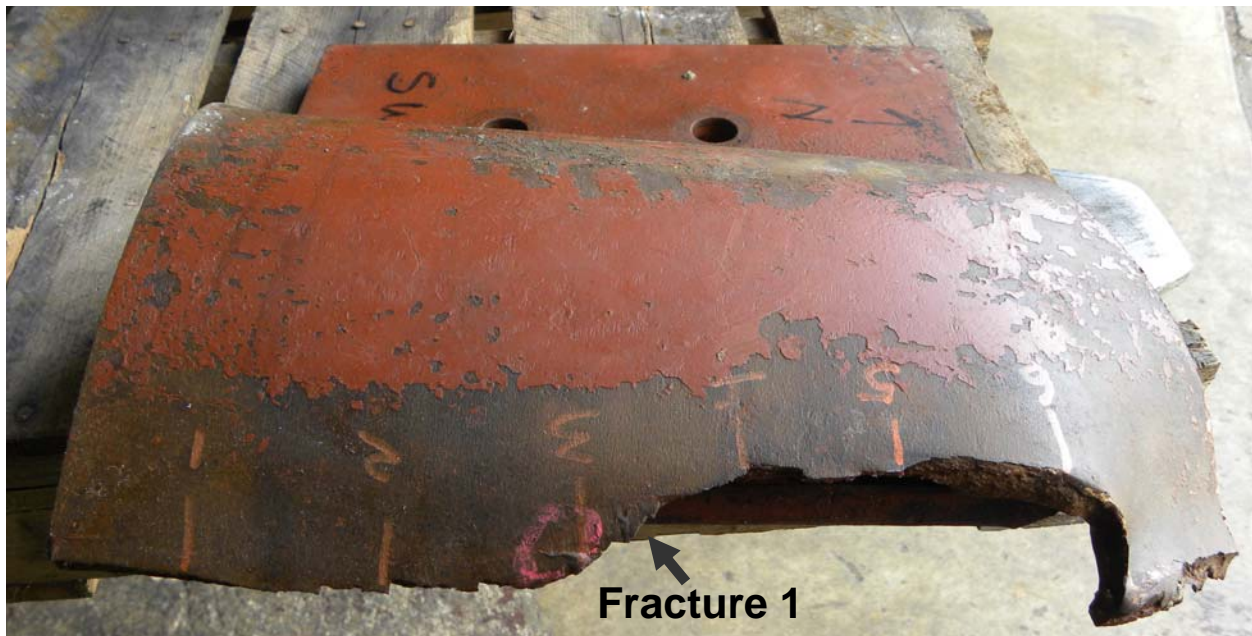
The as-received truss base is shown in Figure 4*. This section consisted of the base and part of the plate section. The top of the plate had fractured completely along its length. (We have identified this as Fracture 1). The plate was bent to one side of the base and the fracture was located below the height of the base. We assume that the base, which had been firmly bolted to the column, had not moved during the roof collapse based on relative locations in Figure 2. Figure 3 thus indicates the plate section had grossly deformed to result in a section of plate bent below the base at the time of final fracture and liberation from the rest of the plate. Evaluation of the fracture surface (Figure 5) indicated the plate had come in contact with the base. Fracture

Figure 4: Base section of support after fracture. Note how web has collapsed onto base. (Note: photos, when appropriate, have been rotated to match original as-constructed orientation).

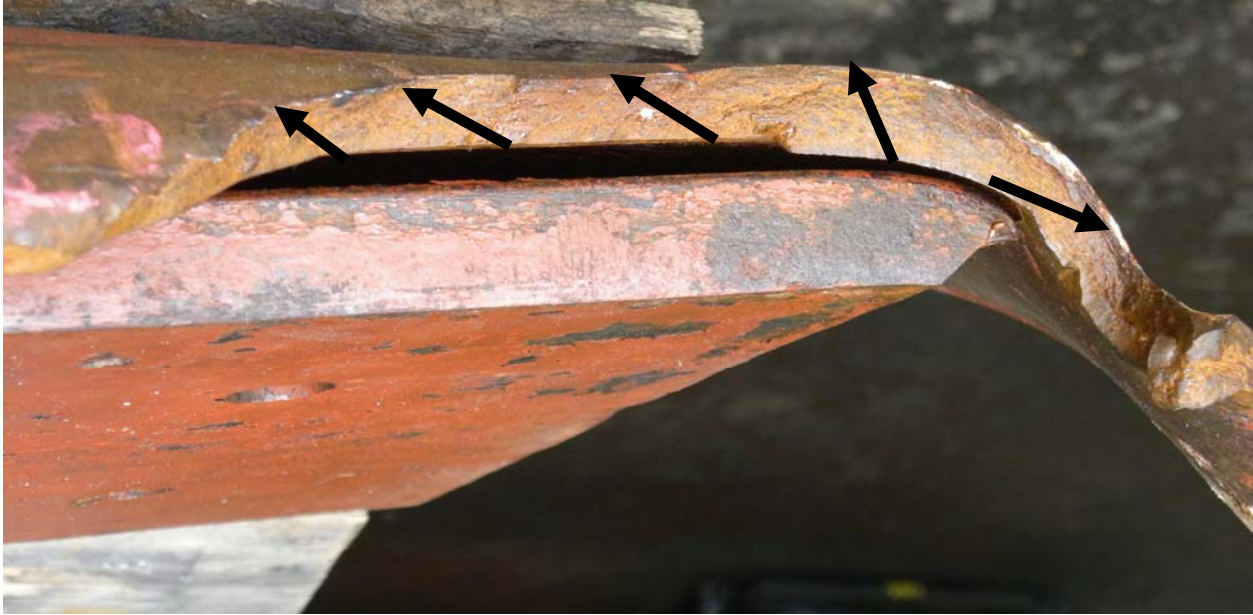
appeared to have initiated at the first point of contact. River markings on the fracture revealed the fracture likely had been a rapid overload fracture and had propagated in both directions as shown in the figure. The origin location indicates this surface had been in tension at the time of fracture.

Figure 5: Close-up view of Fracture 1 on base side of fracture. Arrows show directions of fracture propagation. Morphology is consistent with fracture morphology after severe buckling has occurred.

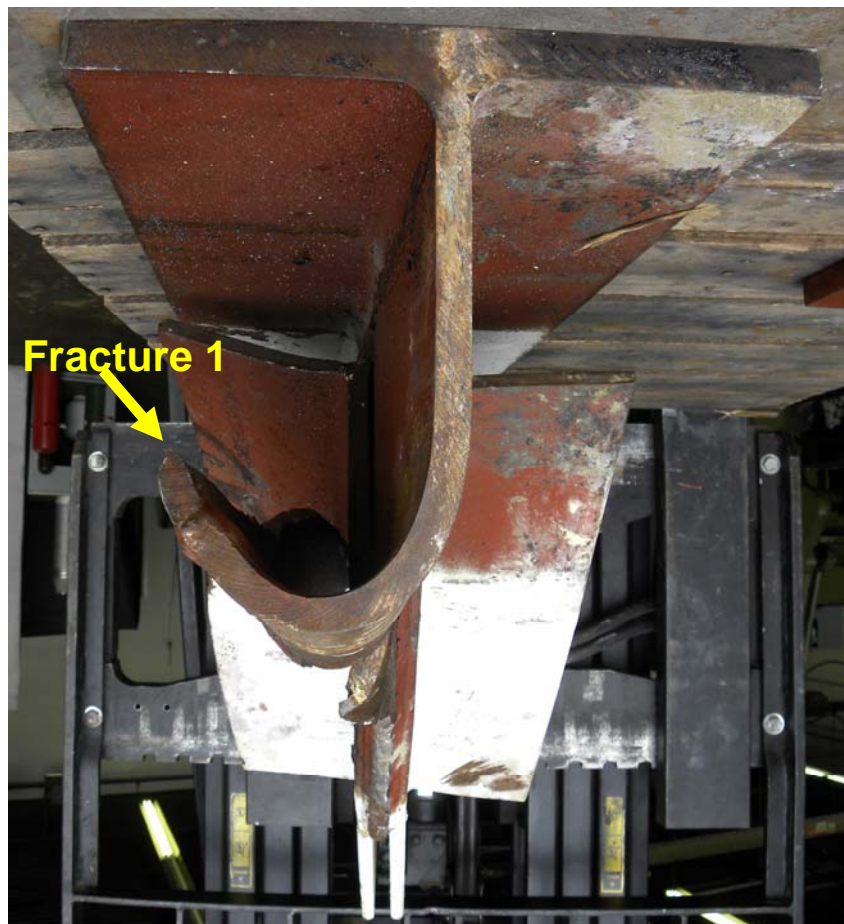
Figure 6 shows the end of truss and support on the truss side of Fracture 1. This figure is analogous to the top photo in Figure 4 but was taken from the opposite side (i.e. the southwest side). The support in end-view was J-shaped, with Fracture 1 located at the bottom of the J. The morphology suggests the support plate had deformed to an S-shape prior to fracture. Fracture had occurred in the plate base material.

Figure 6: End view of as-received top truss member. Note almost complete bending of web on support member.

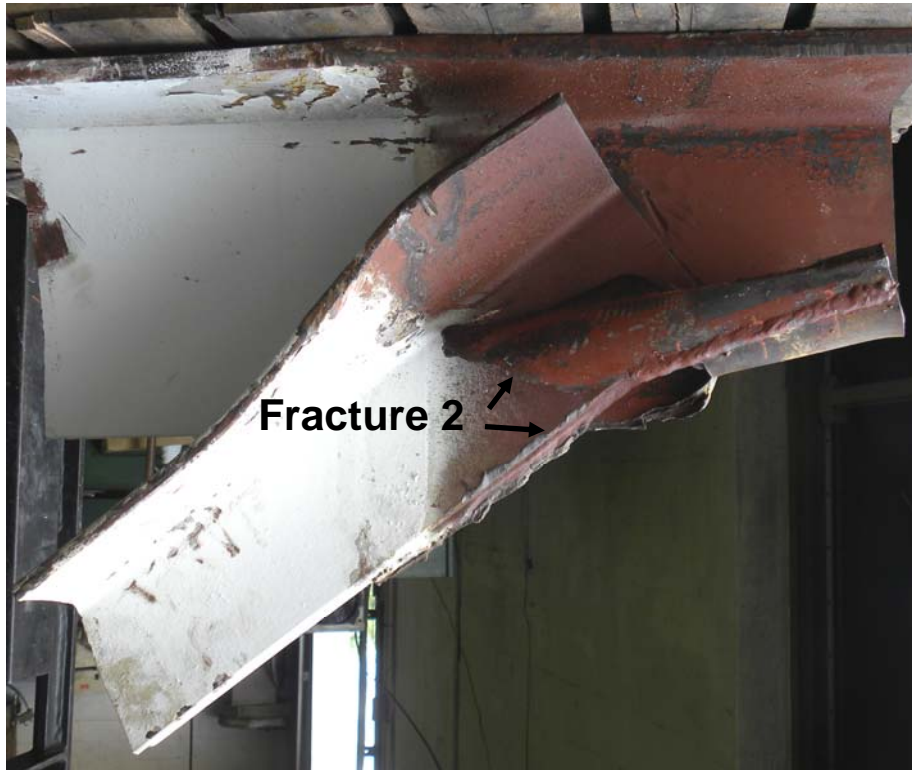
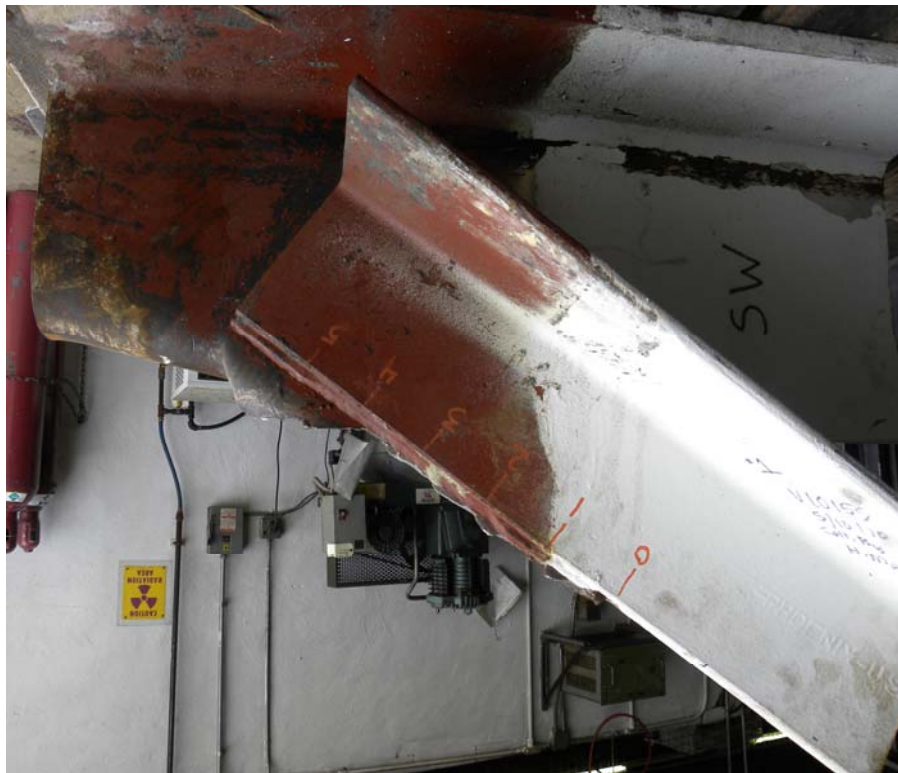
Side views of the truss end are shown in Figure 7. A second fracture was observed in the plate. This fracture ran along the toes of the fillet welds to the diagonal, and then partially along the butt weld before it ended. This fracture (Fracture 2) intersected with the end of Fracture 1 that was located at the diagonal. We did not see any directionality in Fracture 2. We believe this had been rapid fracture that had propagated in the short transverse direction.

Figure 7: Top truss member as viewed from the sides. Arrows point to Fracture 2 on weld.

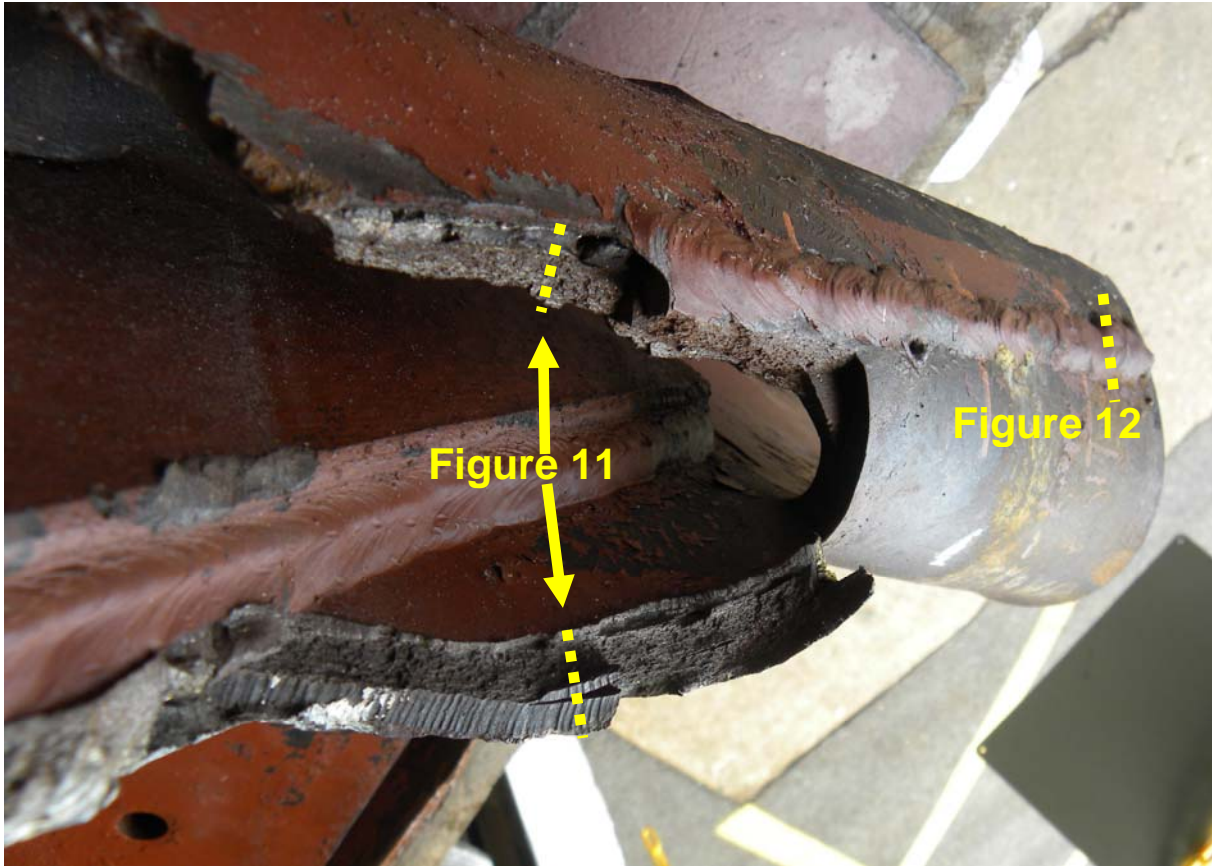
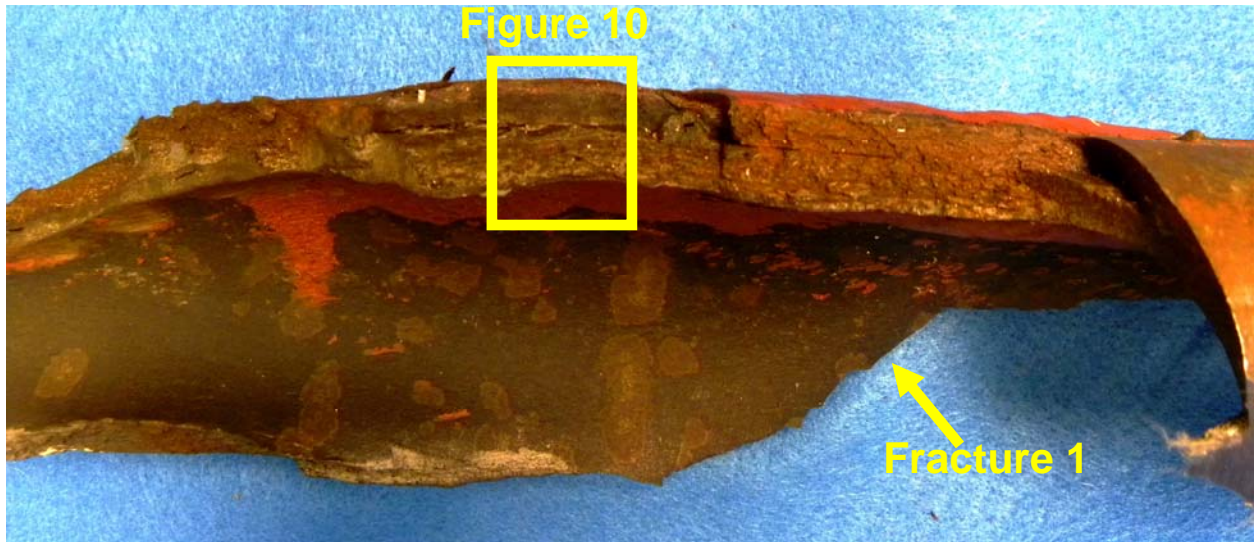
Closer views of Fracture 2 along the butt weld are shown in Figures 8 and 9. We observed that the section had twisted inward in this area such that Fracture 1 was oriented over 90° relative to Fracture 2. Fracture 2 in this area showed an area with a “ridge line” in the center of the fracture that was oriented parallel to the weld surfaces. This section of Fracture 2 was radiographed but no indications were observed. We also noticed one area in this region which did not appear to be fractured. Closer examination (Figure 10) revealed what appeared to be machining marks on half of the surface, with only a miniscule fracture area at its surface. The machining marks indicate we were seeing a section of weld where no fusion had occurred during welding (which would have obliterated the machining marks and resulted in fracture if the area had been fused).

Figure 8: Closer views of Fracture 2. Note “ridge line” in center of fracture in bottom photo.

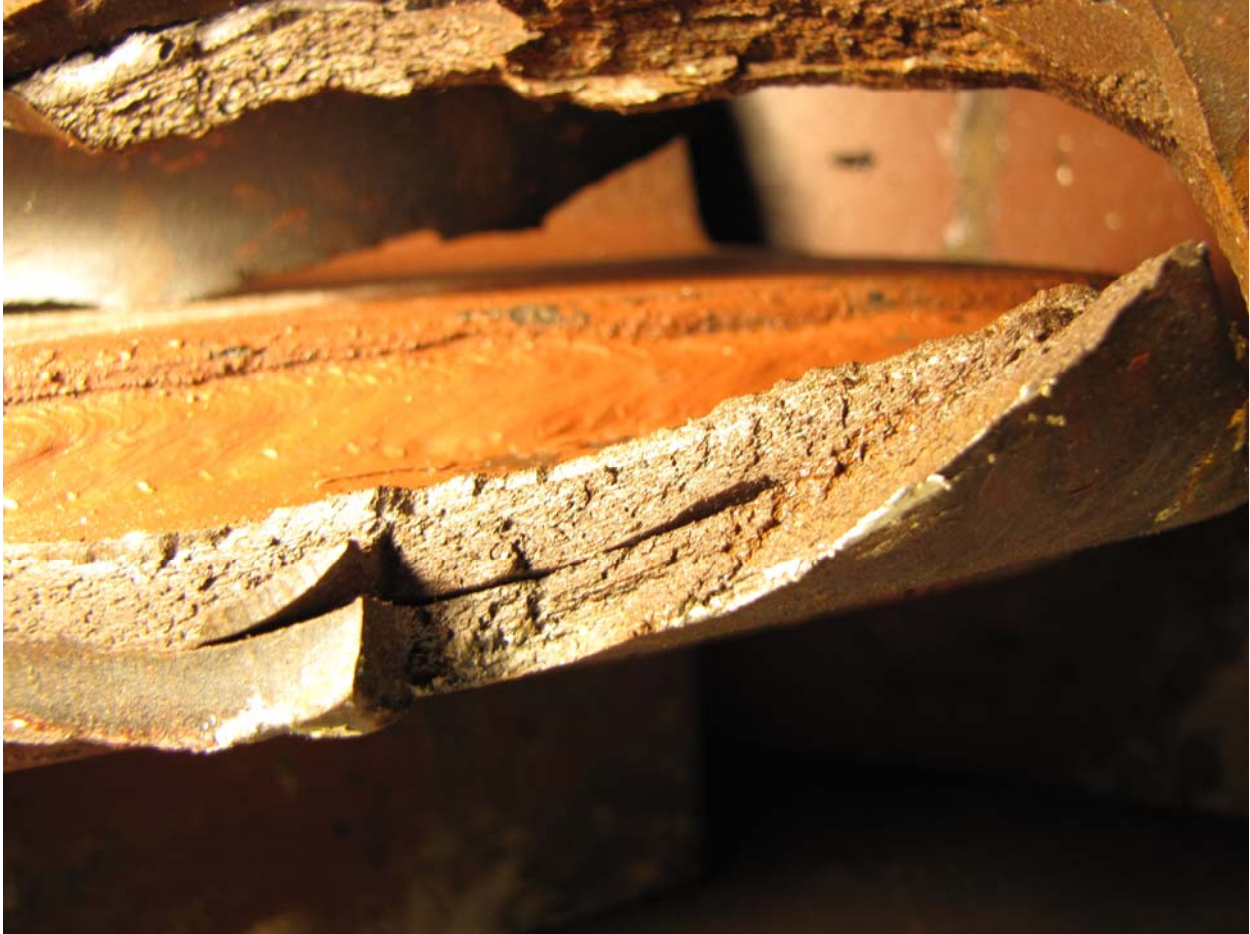
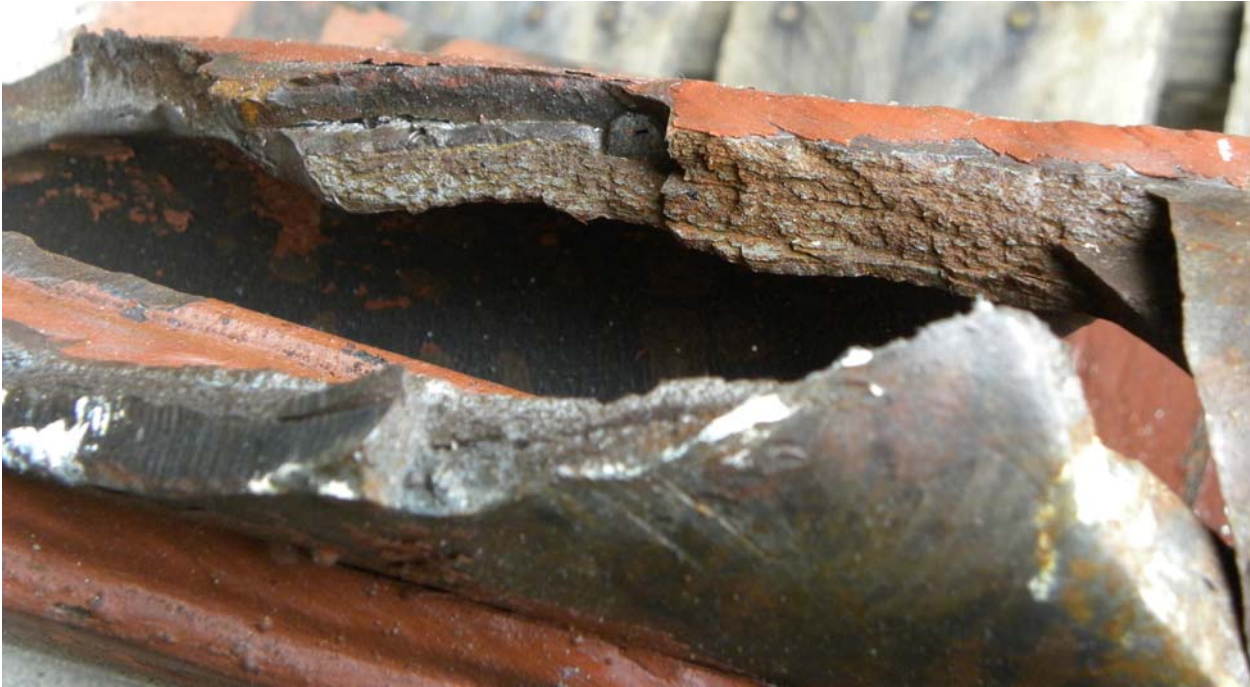
Figure 9: Fracture 2 ridge lines.

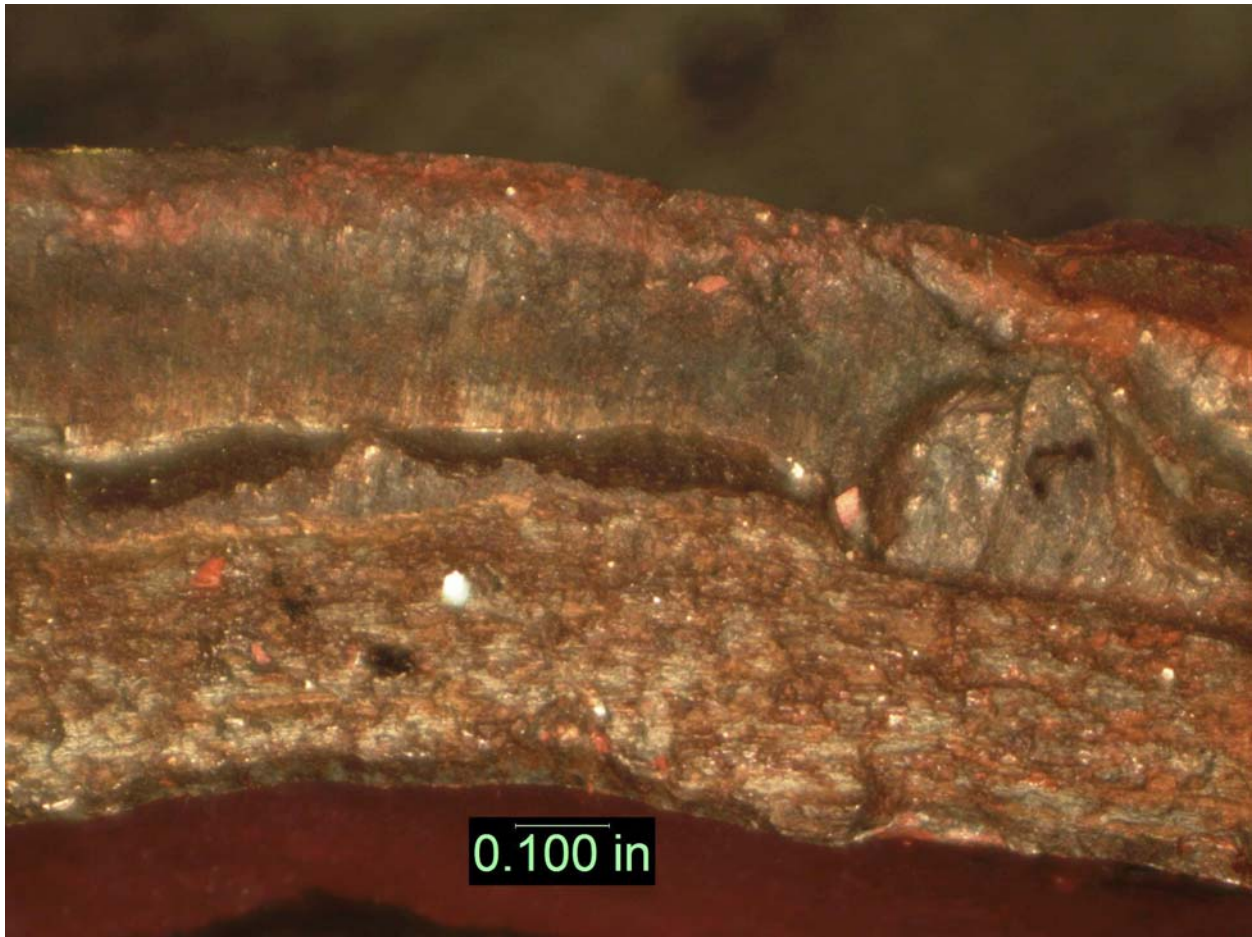
Figure 10: Macroscopic view of area outlined in Figure 9 shows a lack of fusion above the ridge line, as indicated by parallel machining marks which were on the edge of the original member being welded.

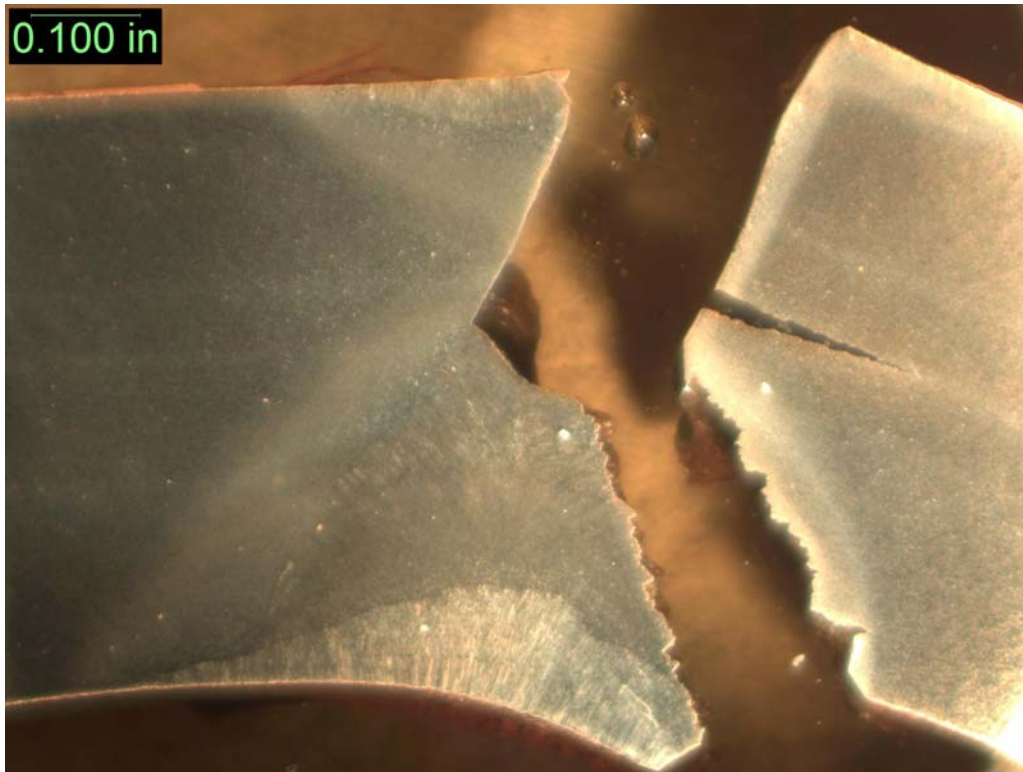
Two metallographic cross-sections had been prepared through the butt weld. One had been in the lack of fusion (LOF) area while the other had been prepared through an intact weld area. Samples were mounted in polymeric compound, ground, polished, and etched to reveal structure. The LOF region showed almost no fusion on one side of the weld (Figure 11). Full fusion was achieved on the other side. Curvature indicates the LOF side had been in tension prior to fracture completion. A crack mid-width had initiated at the root of the weld. We think the tension in bending resulted in a crack starting at the root of the weld on the compression side, resulting in the crack that was exhibited in the form of a “ridge line”. This crack had only progressed a short distance before final fracture running along the weld fusion line was observed.

Figure 11: Lack-of-fusion area cross-section from Fracture 2. Note crack at root of weld running parallel to surfaces. Etch: 2% nital.

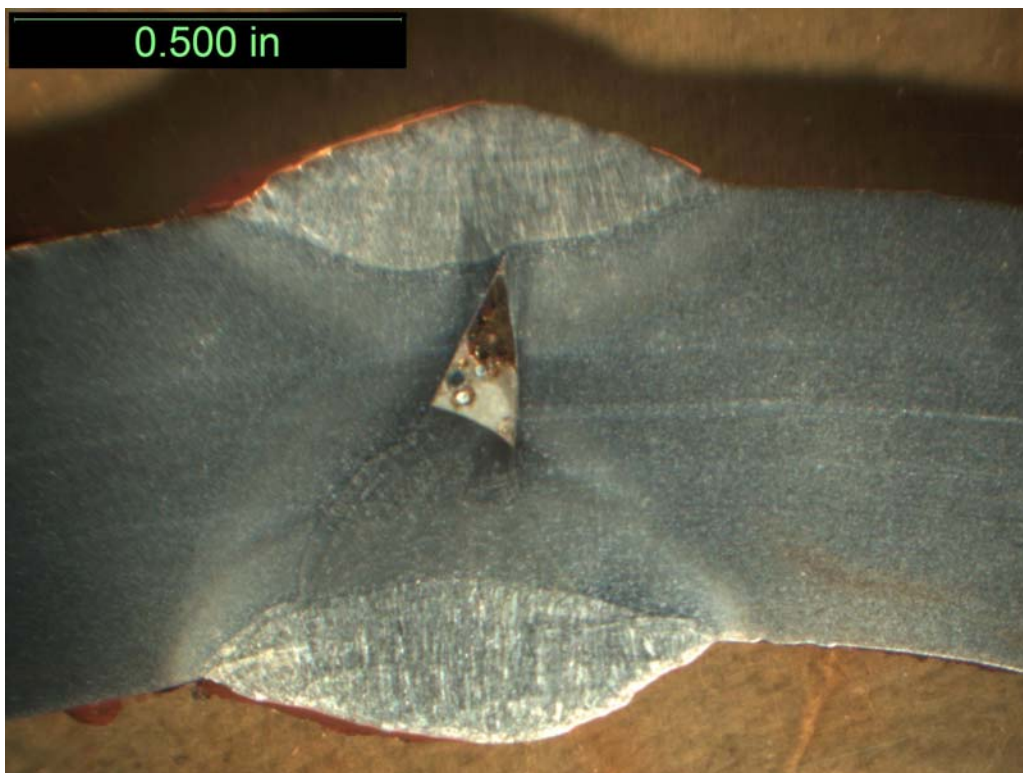
The second cross-section was prepared through an area of unfractured weld. A macroscopic view revealed incomplete penetration across the weld, with a small triangular region of unfused metal between the welds. The footprint of this region was too small to see when the weld was radiographed. The left side appeared to have had a single bevel which had run along its thickness while the right side did not appear to have been prepared at all or, at best, had been beveled only on the bottom corner. The observed lack of full penetration in both weld cross-sections is a violation of ANSI/AWS D1.1.

Figure 12: Cross-section prepared through intact weld area. Note lack of penetration between welds and curvature showing top weld was in tension while bottom weld was in compression during buckling.

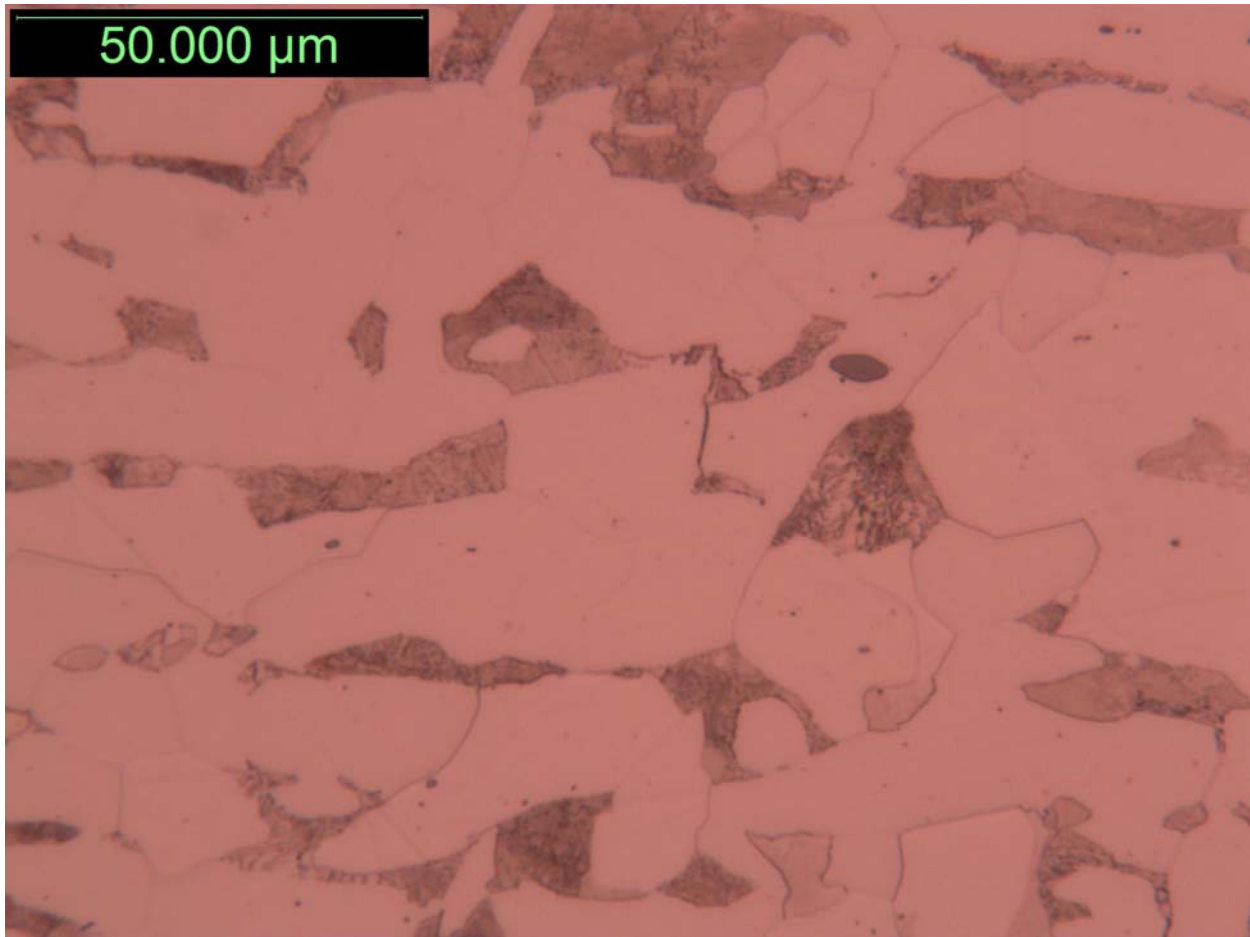
General microstructure was observed from the support plate from the metallurgical mounts. Etched microstructure (Figure 13) was comprised of a combination of ferrite and fine pearlite, typical and expected structure for ASTM A36 steel.

Figure 13: Support base metal microstructure. Structure was comprised of ferrite (light) and fine pearlite, typical and expected for ASTM A36 structural steel. Magnification: 1000X. Etch: 2% nital.
